IS THE QUALITY OF CEMENT A CONTRIBUTING FACTOR FOR BUILDING COLLAPSE IN GHANA?

Humphrey Danso¹ and Isaac Boateng²

School of Civil Engineering and Surveying, University of Portsmouth, United Kingdom

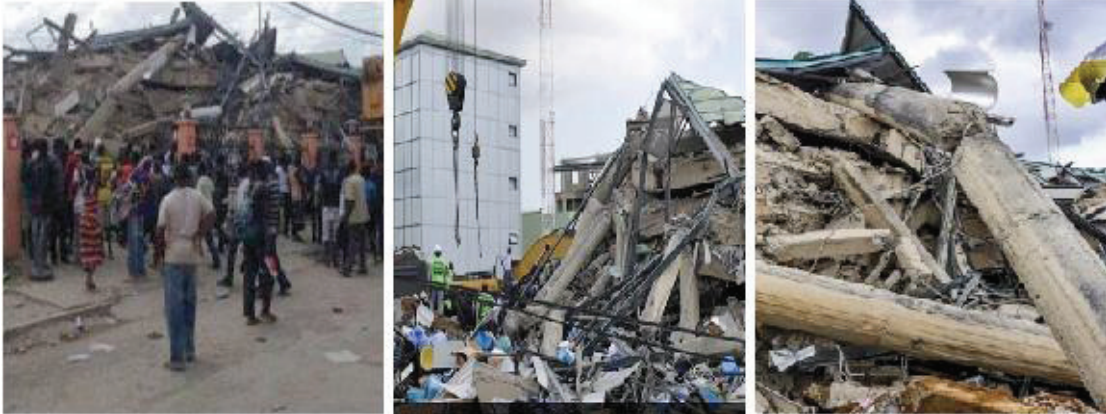
Figure 2: Melcom Shopping Mall Building after Collapse

The appearance of the building before collapse is presented in Figure 1 and after the collapse can also be found in Figure 2. The building experienced a total collapse with all the structural components falling down. This accounted for the high fatality rate.

External View of Building after Collapse

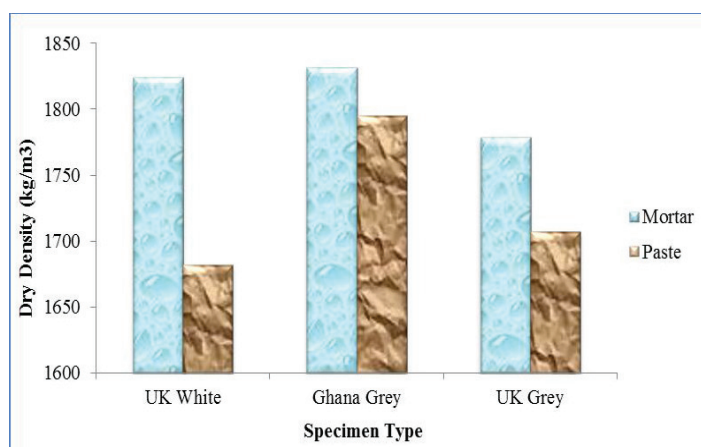
Figure 4: Comparison of Dry Density Results

The comparison of the dry density test results is shown in Figure 4. The results show that the Ghana Grey specimen increased average density of 3% and 5% for mortar and cement paste respectively than UK Grey. In addition, the density of Ghana Grey cement was higher than UK White cement both for mortar and cement past specimen. However, the density of the UK Grey was higher than that of the UK White for cement paste specimen, while it was the opposite for the mortar specimen. It could be concluded the results that the density of Ghana Grey cement is higher than both the UK Grey and UK White cements. This implies that the Ghana Grey cement when used for preparing mortar or concrete could provide more compact unit.
