# Characterization of Physical, Machining and Finishing Properties of Oil Palm Lumber: An Emerging Non-Timber Forest Product in Sub-Saharan Africa

**Abstract--** Environmental problems associated with the rapid depletion of the tropical forest have necessitated the need to look for alternative sources of timber supply. Compression parallel to grain tests, three-point static bending tests, machining tests and finishing characteristics of oil palm lumber, a non-timber forest product were conducted to determine its suitability for furniture production. A compression parallel to the grain of 13 N/mm<sup>2</sup>, a modulus of elasticity of 2924 N/mm<sup>2</sup>, and a modulus of rupture of 25 N/mm<sup>2</sup> at 12% moisture content were obtained.

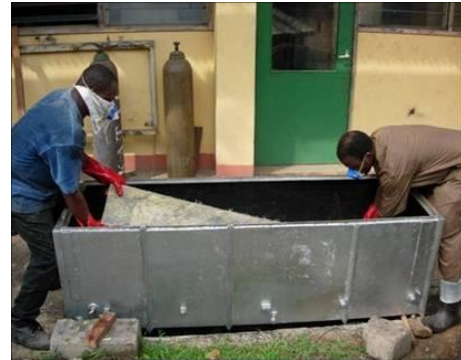
**Fig. 2** Oil palm lumber being treated with preservative

Oil palm trunks of moisture content ranging from 100% to 120% were sawn in the forest into beams of thickness 50mm and lengths 1.8m and 2.4m using a chainsaw machine. The beams were immediately transported to the workshop of the Department of Construction and Wood Technology Education of the University of Education, Winneba for further processing. In order to protect the beams from insects attack, they were immersed into a preservative for three (3) days. The preservative was made up of 2 litres of Dursban 4E and 504 litres of water. Beams being treated with preservative are shown in figure 2. The preservative-treated boards were kiln dried to moisture content between 8% and 10%.

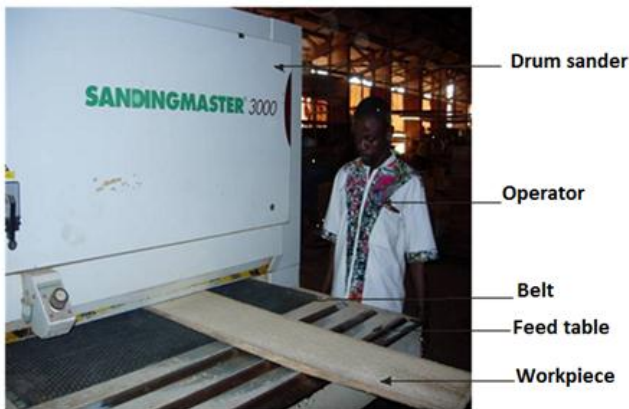
**Fig. 3 The drum sander (model 3000) used**

A drum sander (model 3000) (figure 3) was used to perform the sanding operation. It has an adjustable table to pick any thickness of wood samples and sand to predetermined thickness.

The sanding operation using the drum sander was difficult because the sanding belt got worn out or got torn within two or three cycles of operation. High friction was generated as the raised grains were ground by the drum sander causing burns on the surfaces of the wood samples. The fibres were raised and were sharp enough to wear out the sharpness of the grit. The disc orbit sanding operation was performed after drum sanding in order to ensure that all raised grains that could not be eliminated during the drum sanding operations were successfully removed.

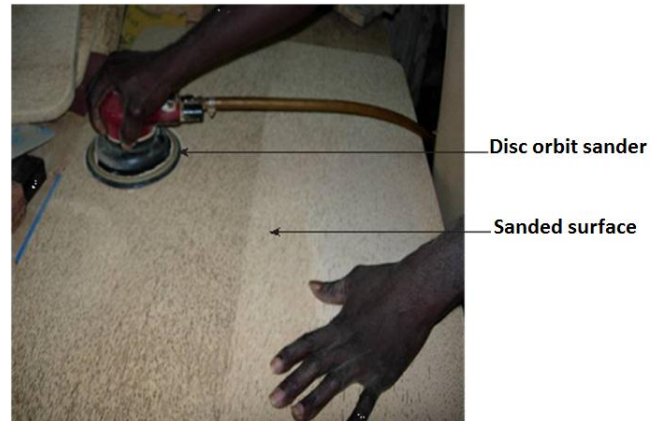
**Fig. 4 Disc orbit sander for sanding oil palm lumber**

Abrasives used for sanding were 60 and 80 grit for initial sanding and 120 grit for light sanding. Finally, the disc orbital sander (figure 4) with abrasive grit of 180 was used for smooth sanding and also for removal of the raised edges after using the drum sander.

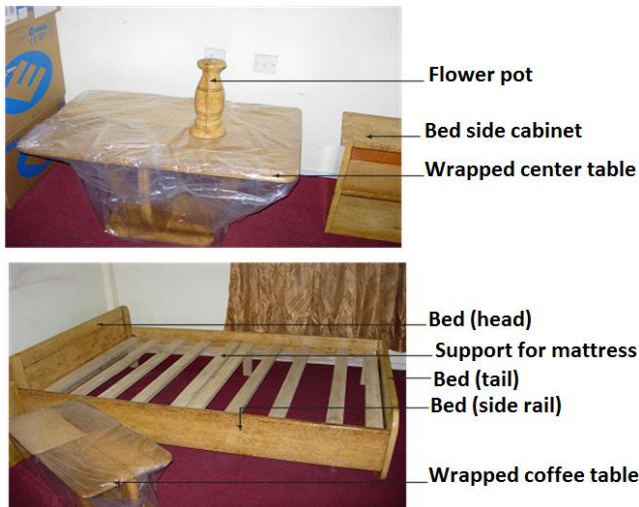
**Fig. 7 Products manufactured from oil palm lumber**

Figure 7 shows flower pot, center tables, bedside cabinet, coffee tables, and a bed produced from oil palm lumber.

Therefore, in an attempt to produce a bed from oil palm lumber, care was taken to ensure that the support for the foam mattress rest on the floor instead of the side rail. Any force exerted on the support for the foam mattress is transmitted to the floor instead of the side rail. It is expected that in the design of wood products using oil palm lumber, manufacturers will take into consideration the maximum force acting on the members in order to prevent failure of the members due to excessive load.
